FINDINGS FROM INTERNAL
AUDITING STUDY *of*
**INSULATION
INTEGRITY
PRACTICES**
to IMPROVE INSPECTION,
TESTING AND PATIENT
OUTCOMES

BY CHERON ROJO, BS, CFER, CRCST, CHL, CIS, CER, FCS, CLINICAL
EDUCATION SPECIALIST—HEALTHMARK INDUSTRIES

ABSTRACT

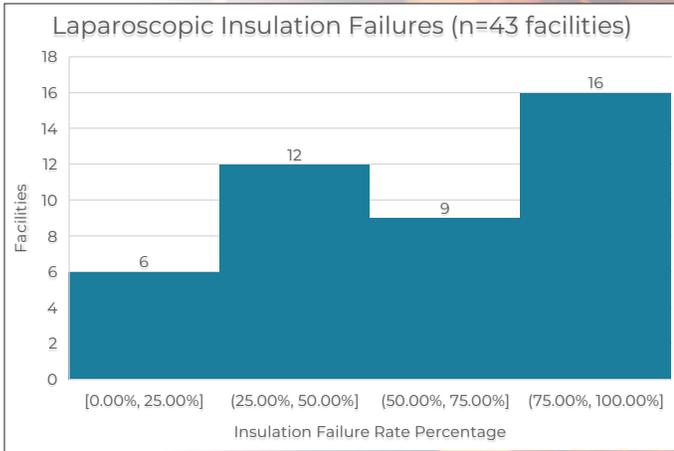
Figure 1: Insulated laparoscopic failures

The retrospective, cross-sectional, 12-month study was conducted from May 2021 to May 2022 at 49 healthcare facilities. Of the 416 instruments tested, 223 showed failures on insulation testing or inspection, and 16 facilities showed a failure rate of 75%–100% across all devices tested (See **Figure 1**). On average, insulated cables demonstrated a 6% failure rate for continuity across 32 facilities (See **Figure 2**). The study also revealed that insulated bipolar forceps had the highest failure rate, with 27 facilities experiencing a 75%–100% failure rate for those devices (See **Figure 3**). In one of the 27 facilities, 19 insulated bipolar forceps were tested from ready-to-use back=up inventory, and 13 of the 19 were identified as having insulation failures (See **Figure 4**).

The results (shown in Figures 1–4) revealed there were numerous contributing factors to unnoticed insulation damage. The factors included:

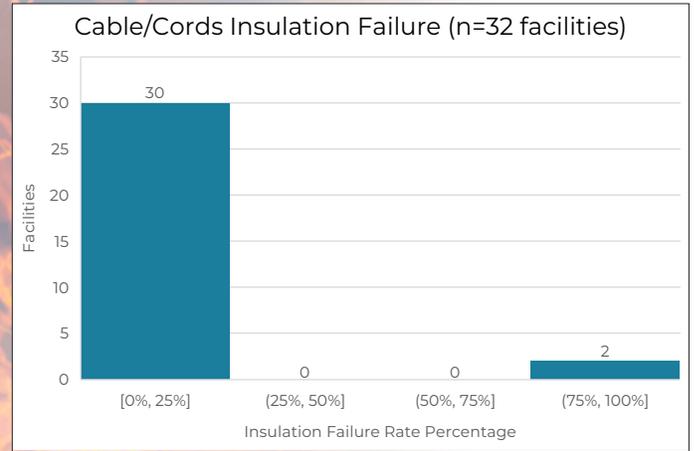
Figure 2: Insulated cable failures

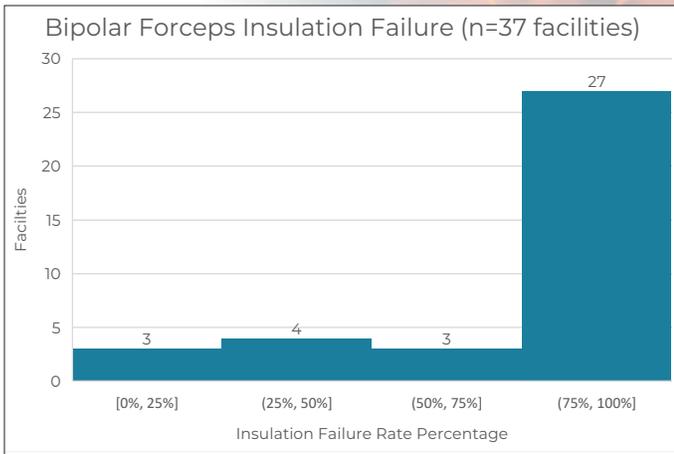
Figure 3: Insulation bipolar forceps failures

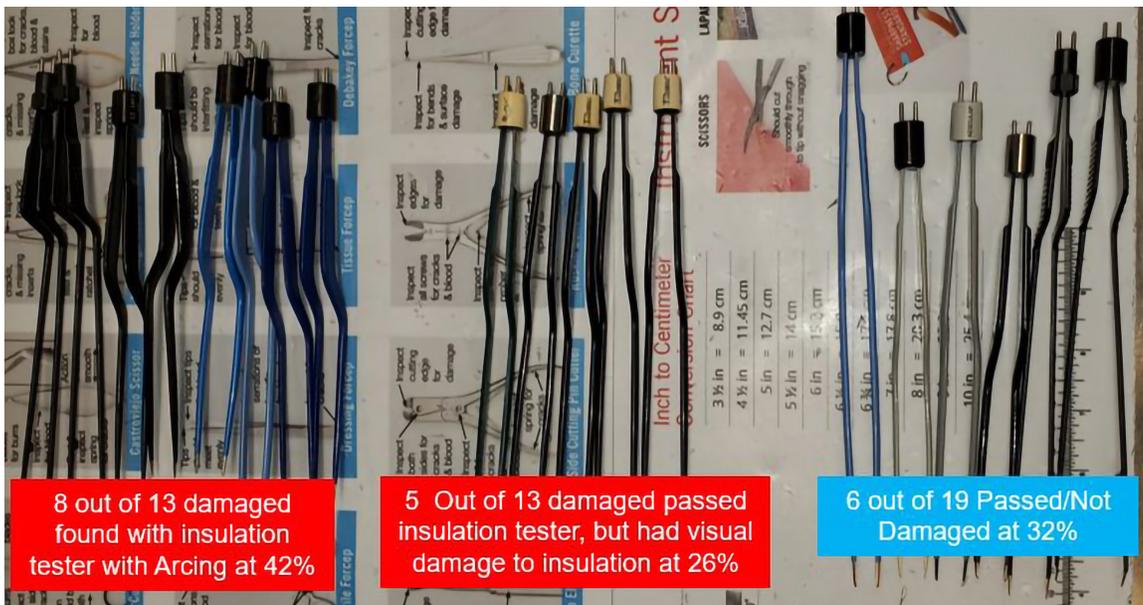
Figure 4: Facility with 13 out of 19 failures for insulated bipolar forceps in ready-to-use back-up instrumentation

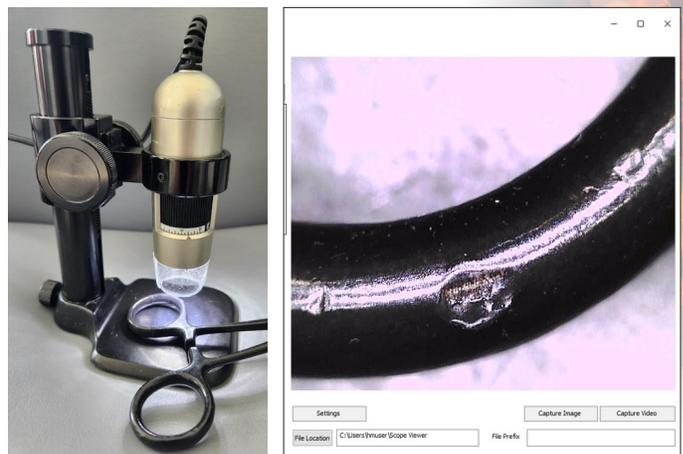
Most facilities have a desktop magnifier at the workstations in Sterile Processing, but that alone is insufficient due to the level of magnification found in desktop magnifiers. Typically, desk magnifiers range from 1.8x to 2.0x magnification, which are some of the lowest found on the market. Although they have their use and place in the department, a much higher magnification is needed to examine insulated instrumentation (see **Figure 6**).

Figure 6: Image on left is an examples of enhanced inspection microscope in use; image on right shows damage seen under magnification

Evaluating an enhanced inspection microscope may be a better solution for identifying insulation damage. Enhanced inspection microscopes can range in magnification (e.g., a USB microscope is 10x to 230x). An enhanced inspection microscope can be used with a variety of instruments and provide image capture and recording, if applicable, as well as a reference library for some models where the images can be stored for users to compare images being examined and observed (e.g., a new instrument compared to the current instrument). Best practice is that high-powered inspection microscopes are available at every workstation to ensure user compliance, as is seen with desktop magnifiers.

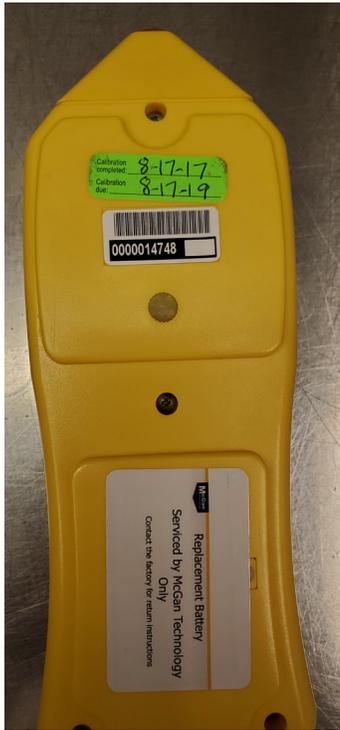
Figure 7: Example of overdue calibration identified in December 2021

3. Compare the insulation tester in question to a new one of the same kind, ensuring there are no missing or damaged accessories—and that the tester is calibrated (if applicable), which is typically annually (see **Figure 7**). This can be accomplished by working with the insulation tester manufacturer. Compare the current tester to another type in question to evaluate where it lacks in sensitivity. While performing a test on the same insulated instrument with both testers, one can more easily evaluate the depth of detectability (see **Figure 8**).

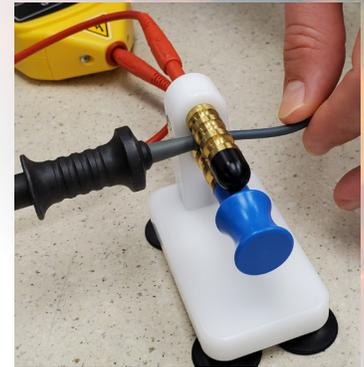
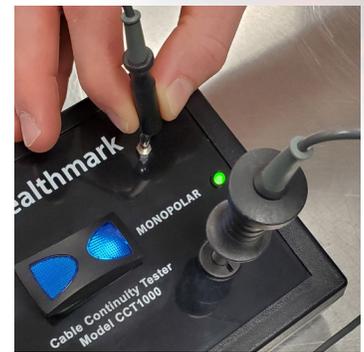
Figure 9: Examples of integrity and continuity testing

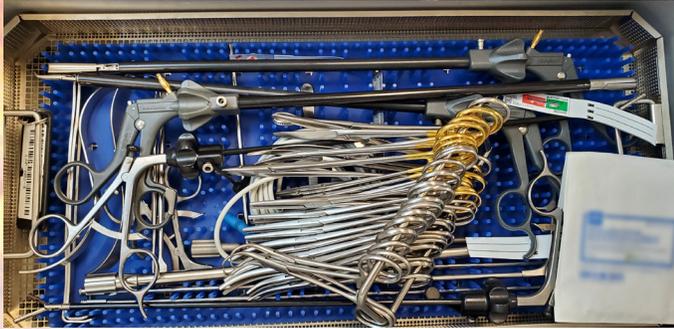
Figure 10: Example of a single-layer tray with insulated and metal instrumentation mixed together

- Refer to any internal policies and procedures that pertain to inspection and testing as a guide to ensure they are followed.
 - If the laparoscopic container/trays consist of a mix of insulated instruments that are actively monitored throughout the procedure and only need to be inspected, not tested, then the assessment will have specific questions for the employee (e.g., “What is the difference between the other insulated instruments in the container/tray?” and, “Which insulated instruments are inspected and tested versus just inspected?”).

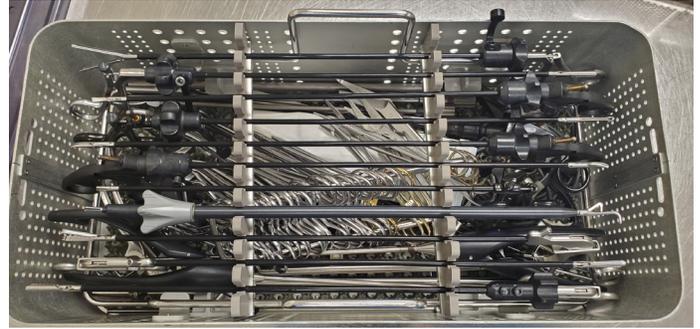
Figure 11: Example of a single-layer tray with insulated and metal instrumentation mixed together

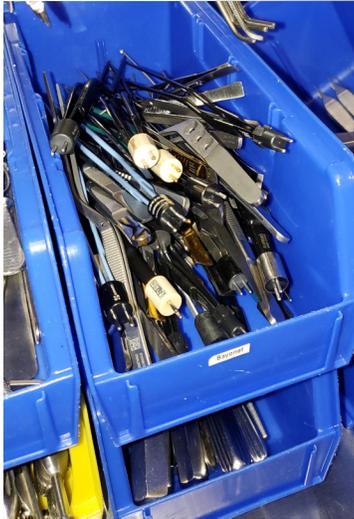
When auditing back-up insulated instrumentation, identify any excessive amount or mixed insulated and metal instruments for any specific insulated instrument category (e.g., bipolar forceps, insulated scissors). (See **Figure 12**). Adson insulated forceps need to be separated from

Figure 12: Insulated bipolar forceps mixed with metal instrumentation

7/8-inch insulated forceps; this is because Adson forceps are half the size, and the distal metal tips can scratch against the insulation of the larger forceps when users retrieve or sift through the bin or drawer. Laparoscopic instrumentation with insulated shafts should be separated from non-insulated devices, and laparoscopic devices with insulated handles need to be separated from non-insulated handles to prevent scratching the insulated handles (alternatively, the insulated handles can be phased out or moved). For third-generation, laparoscopic take-apart instrumentation, the insulated sheaths should be separated from the metal working mechanism inserts as those will also scratch against the insulated shafts. Insulated monopolar and bipolar cables should be separated from all instrumentation and left in the original package

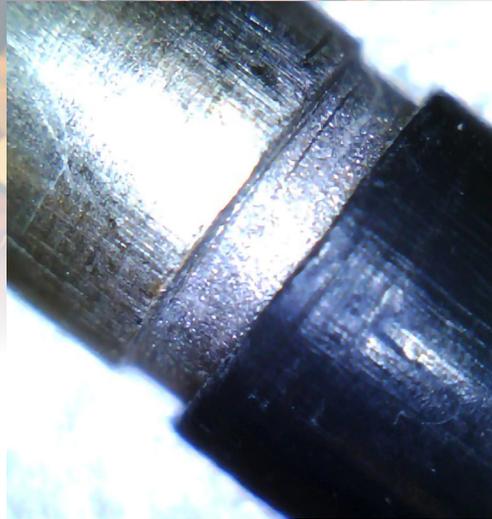
Figure 13: Clean pull-back from an insufficient repair

- Pull-back at the distal end for laparoscopic instrumentation that is clean, with no frayed insulation for non-take-apart devices (see **Figure 13**). *Note: This can be attributed to an insufficient repair overlooked by the repair technician, or lack of training for the service technician to identify an inadequate repair.*

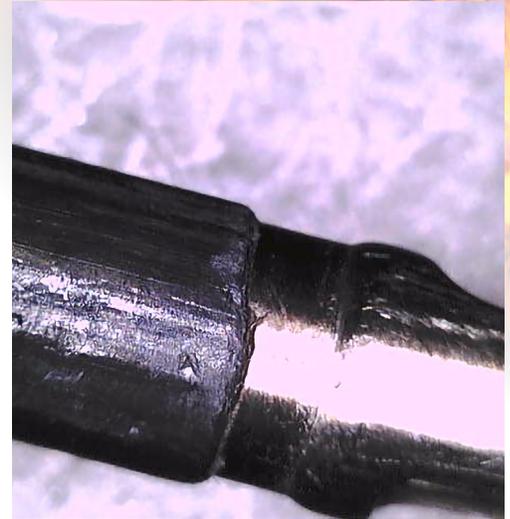
Figure 14: Old and frayed pull-back from an insufficient repair

- Pull-back at the distal end for laparoscopic instrumentation that has frayed insulation for non-take-apart devices (see **Figure 14**). *Note: This example shows old damage overlooked by the repair technician and also reflects lack of education for the technician to identify an insufficient repair.*

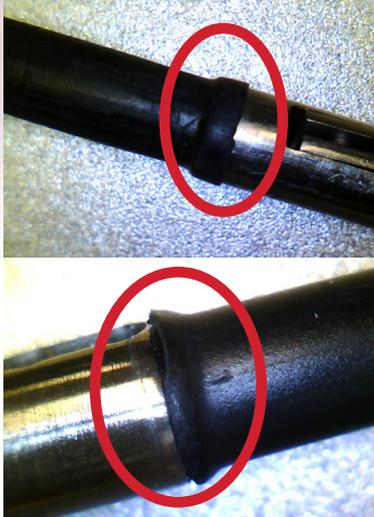
- Insulation lay over (“hangnail effect”), where the insulation is laid over the distal working mechanism instead of being flush against it. Over time, this can cause insulation to separate, or pieces of insulation may fray and pull back like a hangnail (see **Figure 15**). These issues can be attributed to an insufficient repair, overlooked damage by the service technician, or lack of education education for the technician to identify an inadequate repair.

Figure 15: Example of “hangnail effect”; image on top shows insulation laid over, and image on bottom shows pulled-back insulation pieces

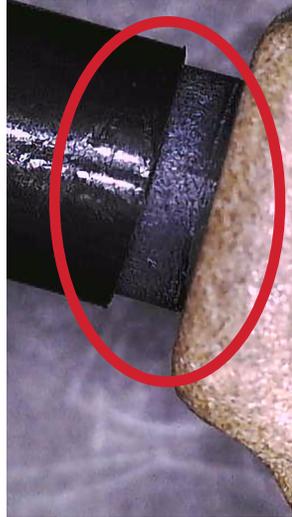
- Pull-back at the proximal end for laparoscopic instrumentation that has separated from the base/handle for non-take-apart (see **Figure 16**). This can be contributed to inadequate damage evaluation by the repair service as well as lack of education for the technician to identify damage.

Figure 16: Pull-back/separation from insulated shaft (from proximal handle)

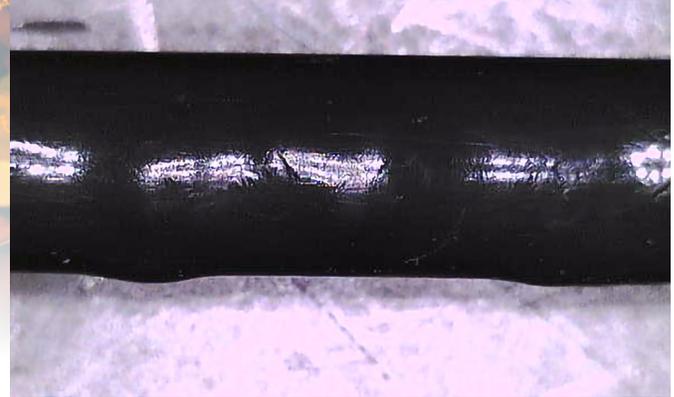
Figure 17: Inadequate repair of laparoscopic insulated shaft

- Newly insulated laparoscopic instrumentation with a glossy look and bumps along the shaft (see **Figure 17**). This is an insufficient repair where the inner insert was not completely cleaned/removed of old insulation, then insulated over the existing pieces and overlooked by the technicians due to a lack of education to identify an adequate repair.

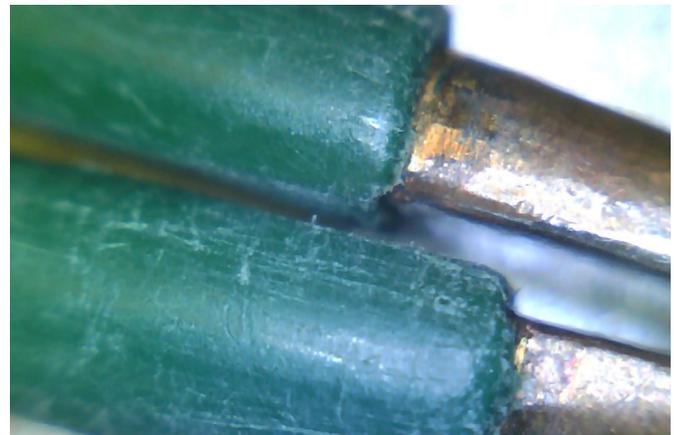
Figure 18: Example of old insulation damage

- Signs of wear, including nicks, scratches and gouges on insulated instrumentation (see **Figure 18**). *Note: This represents previous damage overlooked by the repair technician and a lack of training for the technician to identify damage.*

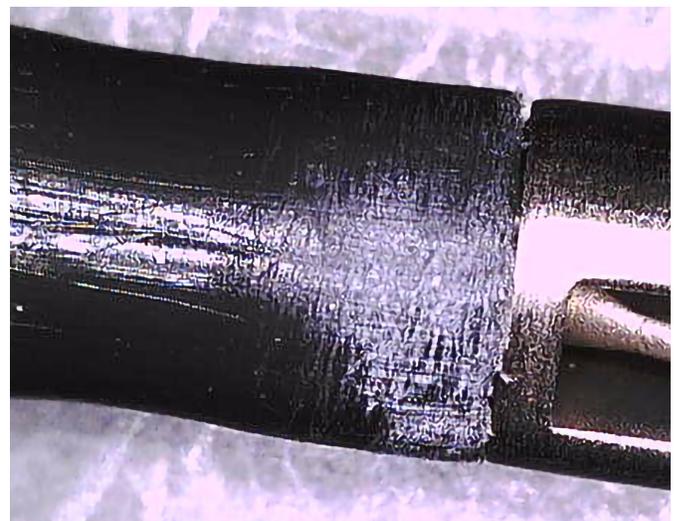
- Insulation that is gray, white, dull in color, and/or fuzzy (for all insulated instrumentation) (see **Figure 19**). *Note: This also represents previous damage overlooked by the repair technician and lack of education for the technician to identify damage.*

Figure 19: Discoloration and old damage

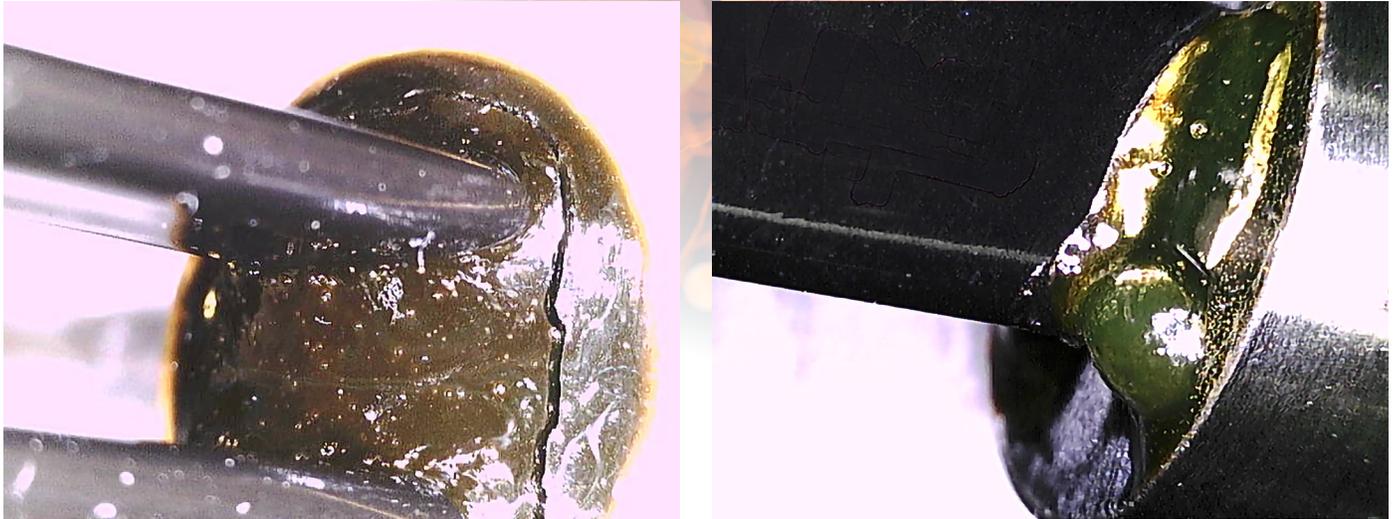
- Separation or excessive amount of epoxy resin that lifts from the base at the proximal end of an insulated bipolar forceps (where the base connects to the tins of the forceps) (see **Figure 20**). *Note: This, too, can be attributed to insufficient repair overlooked by the repair technician or insufficient repair technician education to help them identify damage or inadequate repairs.*

Figure 20: Image on left shows separation of base in an insulation bipolar forceps; image on right show excessive amounts of epoxy resin
