# Shaving Down Obstacles for Verification in Testing and Inspection of Shaver Handpieces: Case Study (2023-2024)

BY CHERON ROJO, BS, FCS, CHL, CIS, CER, CFER, CRCST, SENIOR CLINICAL EDUCATION SPECIALIST—HEALTHMARK, A GETINGE COMPANY

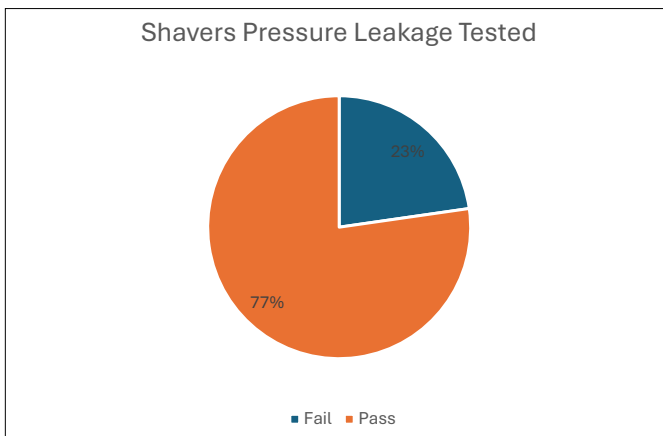
The 12-month study was conducted from May 2023 to May 2024 at 28 healthcare facilities across 10 states, with a total of 28 shaver handpieces inspected. For the orthopedic shaver seal pressure leakage test, 22 were tested and five exhibited seal integrity failures (a 23% failure rate; see **Figure 1**). The study revealed that internal

Figure 1: Leakage pressure Integrity failures

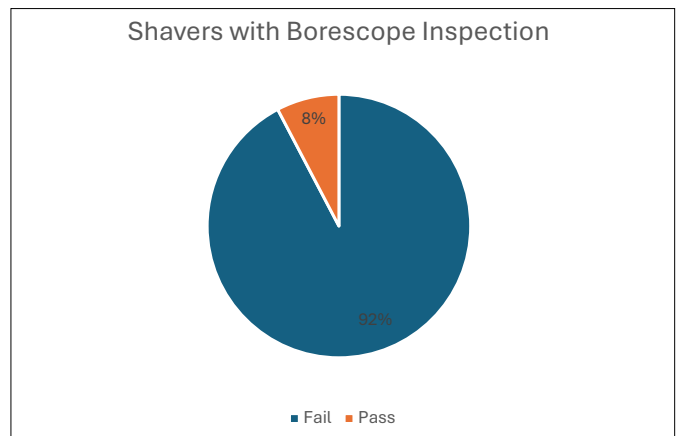
abnormalities within the lumens of the shaver had the highest failure rate (92% of the 26 examined), and 24 demonstrated integrity failures (see **Figure 2**). For the external surface inspection of 13 shavers, 10 (77%) were identified with an integrity failure (see **Figure 3**). Lastly, of the 10 shavers tested for residual protein, eight had traces of protein, representing a failure rate of 80% (see **Figure 4**).

Figure 2: Borescope internal inspection of both lumens within the shaver

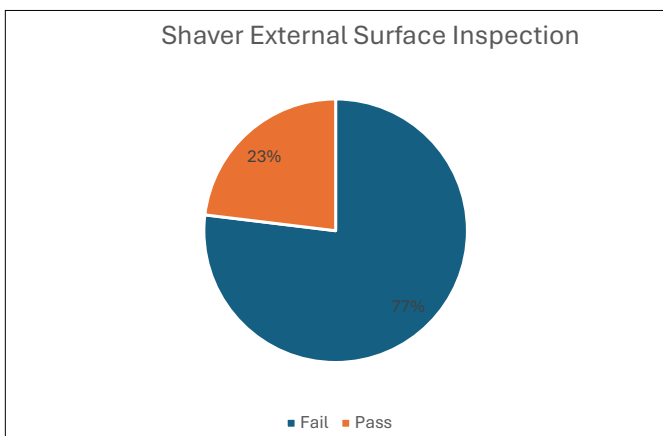
Figure 3: Shaver external surface inspection

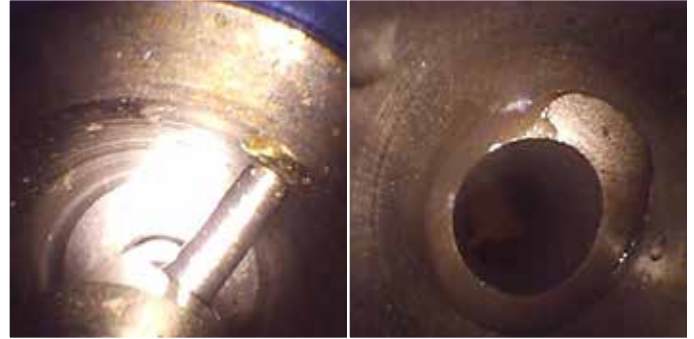
**Figures 6A and B:** Identified internal debris with the use of a borescope

Two facilities were identified with insufficient cleaning brushes for both the internal channels and fork area, and there was no internal borescope inspection. (See **Figures 6A** and **6B**.) Lastly (regarding the debris behind the internal lever rotating ball), the facility was not aware of the IFU for the specific shaver handpiece stating the lever was to be removed during the cleaning process.

- Lack of tools to effectively clean internally (e.g., multiple lumens of different lengths and diameters, and the drive fork area). (See **Figures 6A** and **B**.)
- Lack of cleaning tools externally (e.g., around the buttons, lever, serrations dependent on the model, and silicone inserts). (See **Figure 8**.)

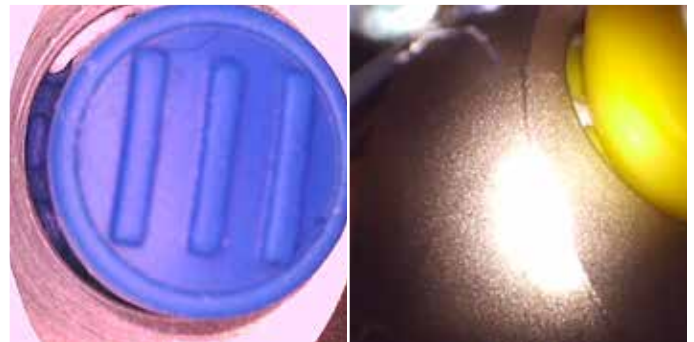
**Figures 8A and B:** Identified external debris (around the buttons) with the use of an enhanced microscope

In both facilities (see **Figures 8A** and **8B**), the technicians were using a sponge to clean the handpiece and cable as a whole and not using a block-style brush to clean around the buttons, lever and handle serrations. Moreover, an enhanced microscope or desktop lighting tool was not being used to identify debris.

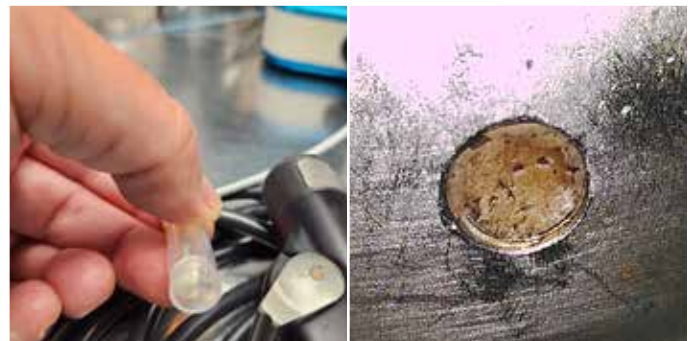
**Figure 10A & B** Identified external debris that tested positive for residual protein (damaged silicone insert)

An external silicone insert, used to cover the screw to hold the lever in place, had protein detected and significant integrity damage (e.g., gouges and recessed areas to expose the hole). (See **Figures 10A** and **10B**.) There were no enhanced inspection microscopes to identify damage and also no residue protein tests.
